Service Bulletin

SUBJECT

Drive Line

Alignment Tool

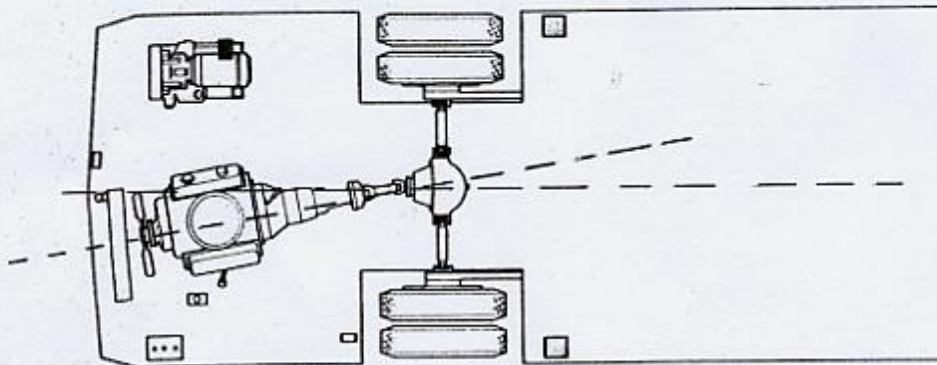
It is then necessary to determine if drive line is properly indexed. (This is necessary because the engine is canted in the coach with respect to the drive train) See figure (1) page two

Fig. (1) Shows inclination of engine trans package as compared to third member drive components: (indexing takes care of this problem)

- C.1. Unscrew the retaining collar at the slip yoke and pull the drive line apart (still holding it perpendicular to your chest) line up the U joints, then move male portion (the end closest to you) Two teeth to the left; install together and screw the retaining collar back on.
