Service Bulletin

DATE March 1, 1977

NUMBER 2907-30002

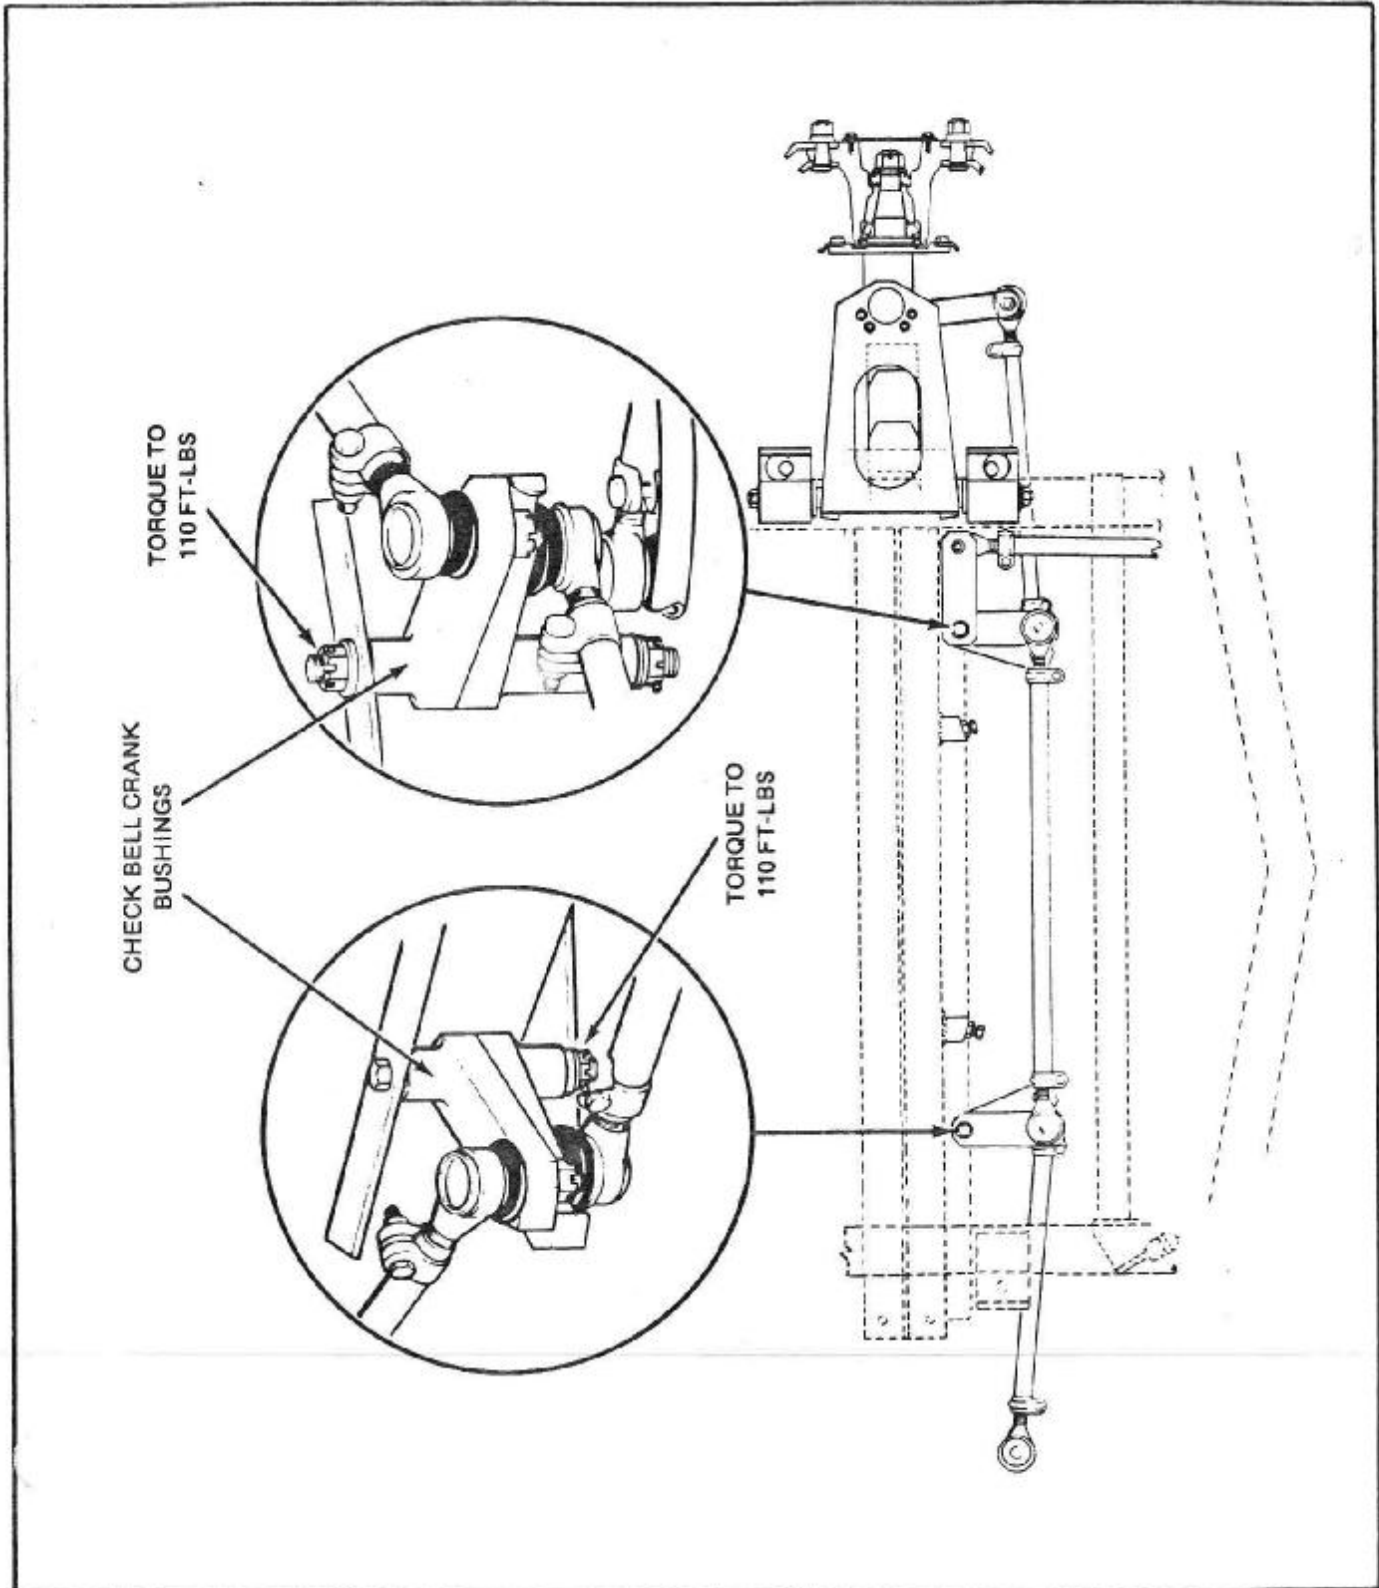
<p>ATTENTION: SERVICE MANAGER</p>	<p>GROUP 7</p>
<p><u>DESCRIPTION</u></p> <p>This bulletin provides instructions for proper torque of the bellcrank nuts on the coach steering linkage.</p> <p><u>COMPLIANCE</u></p> <p>Owners are urged to check and tighten bellcrank nuts to avoid premature failure of the bellcrank bushings.</p> <p><u>INSTRUCTIONS</u> (See attached illustration)</p> <ol style="list-style-type: none"> 1. With coach on hoist check left and right bellcrank nuts. Each nut should be tightened to 110 ft lbs. 2. Any replacement of a bellcrank bushing requires that the bellcrank nut be tightened to 110 ft-lbs. 3. It is recommended that these nuts be checked and retorqued to 110 ft lbs after 1000 miles of operation, and again after 5000 miles of operation. 4. Bellcrank bushings should be checked every 10,000 miles after initial torquing. To check, place coach on hoist and vigorously shake steering links. Note the amount of movement of bolt in bellcrank housing. Replace any bushing that is worn. <p>F.M.C., AS OF 12/31/75, NO LONGER HONORS PARTS OR LABOR REIMBURSEMENT AS OUTLINED IN THIS BULLETIN</p>	<p><u>SUBJECT</u></p> <p>Torque requirements for bell crank bolts.</p> <p>Coaches 00645 and up</p> <p><u>MODEL (S) AFFECTED</u></p> <p>All Transit Coaches from 00645 and up</p>
