Service Bulletin

DATE December 1, 1976

NUMBER 2902-30001

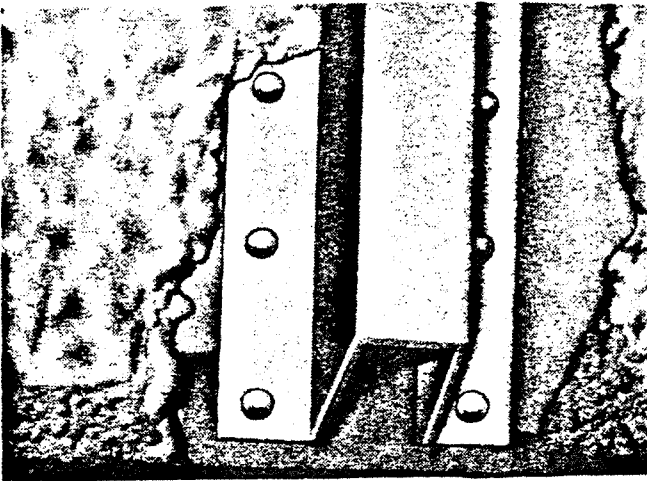
(A) Good section at frame proper cut-away of foam for rivet inspection

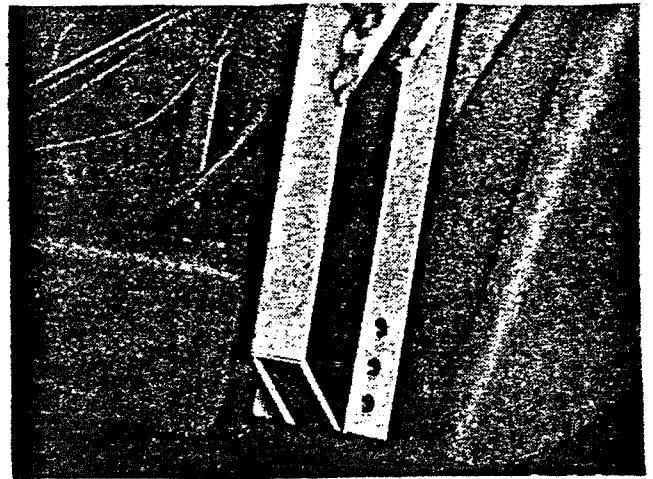
(B) Right front section with missing rivets

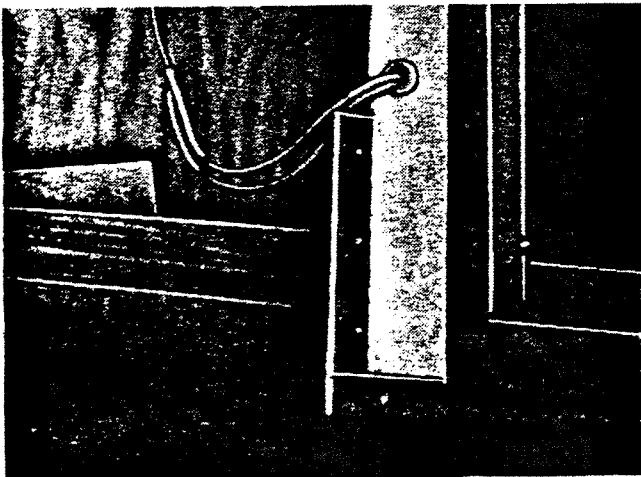
(E) Passenger door frame pulled away from lower frame

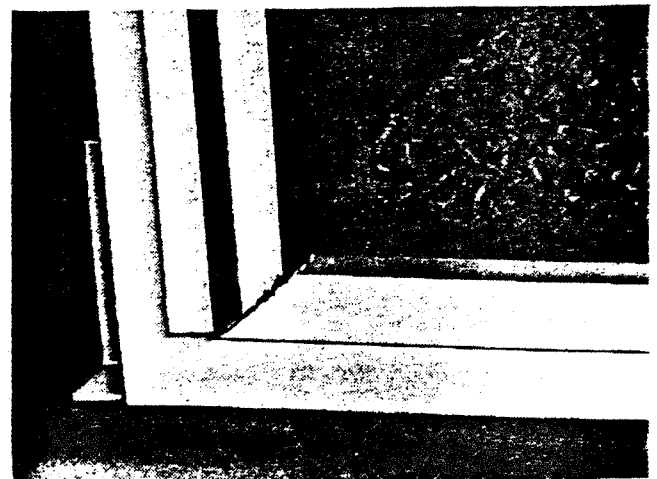
(F) Hairline crack lower aft corner of passenger frame

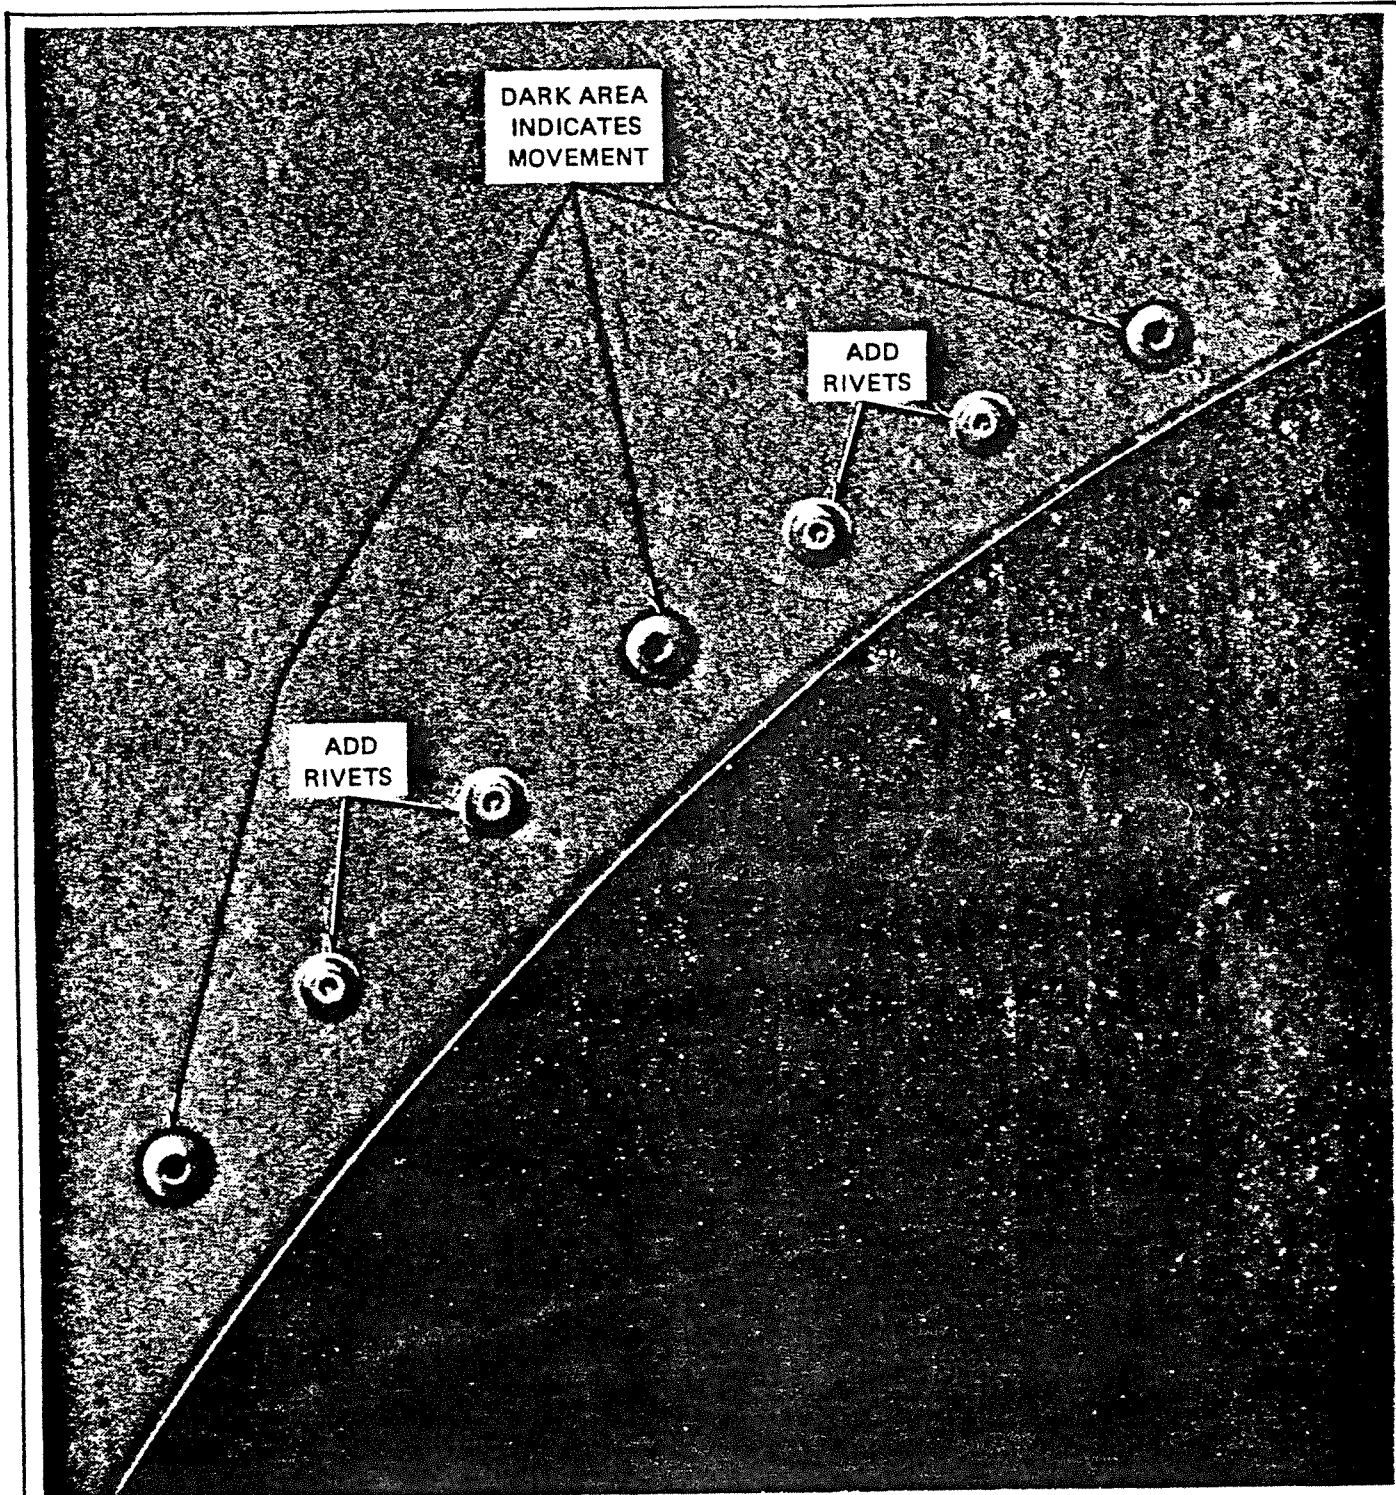
FIGURE 2. SHEAR PANEL TO WHEEL WELL CONNECTION.

<p>ATTENTION: SERVICE MANAGER</p>	<p>GROUP 2</p>
<p>3. Inspect all body section to frame mounts and door for missing rivets, possible movement or disfiguration of rivets (Figure 2) or movement of body section or door frame away from lower frame (Figures 1 and 3).</p> <p>4. Inspect shear panels for missing rivets, possible movement or disfiguration of rivets (Figure 2) or movement of shear panel away from upper body sections. Note: If rivets show signs of movement, add two new rivets between each pair of existing rivets as shown in Figure 2.</p> <p>5. If all upper body section to lower frame rivets are in place and show no signs of deterioration, no reinforcement is necessary <u>except</u> at the right and left body sections (L4 and R4, Figure 3) forward of the rear wheels. New frame reinforcing angles will be added at these points regardless of the condition of the existing section and rivets.</p>	<p>SUBJECT Frame Reinforcement Instructions</p>

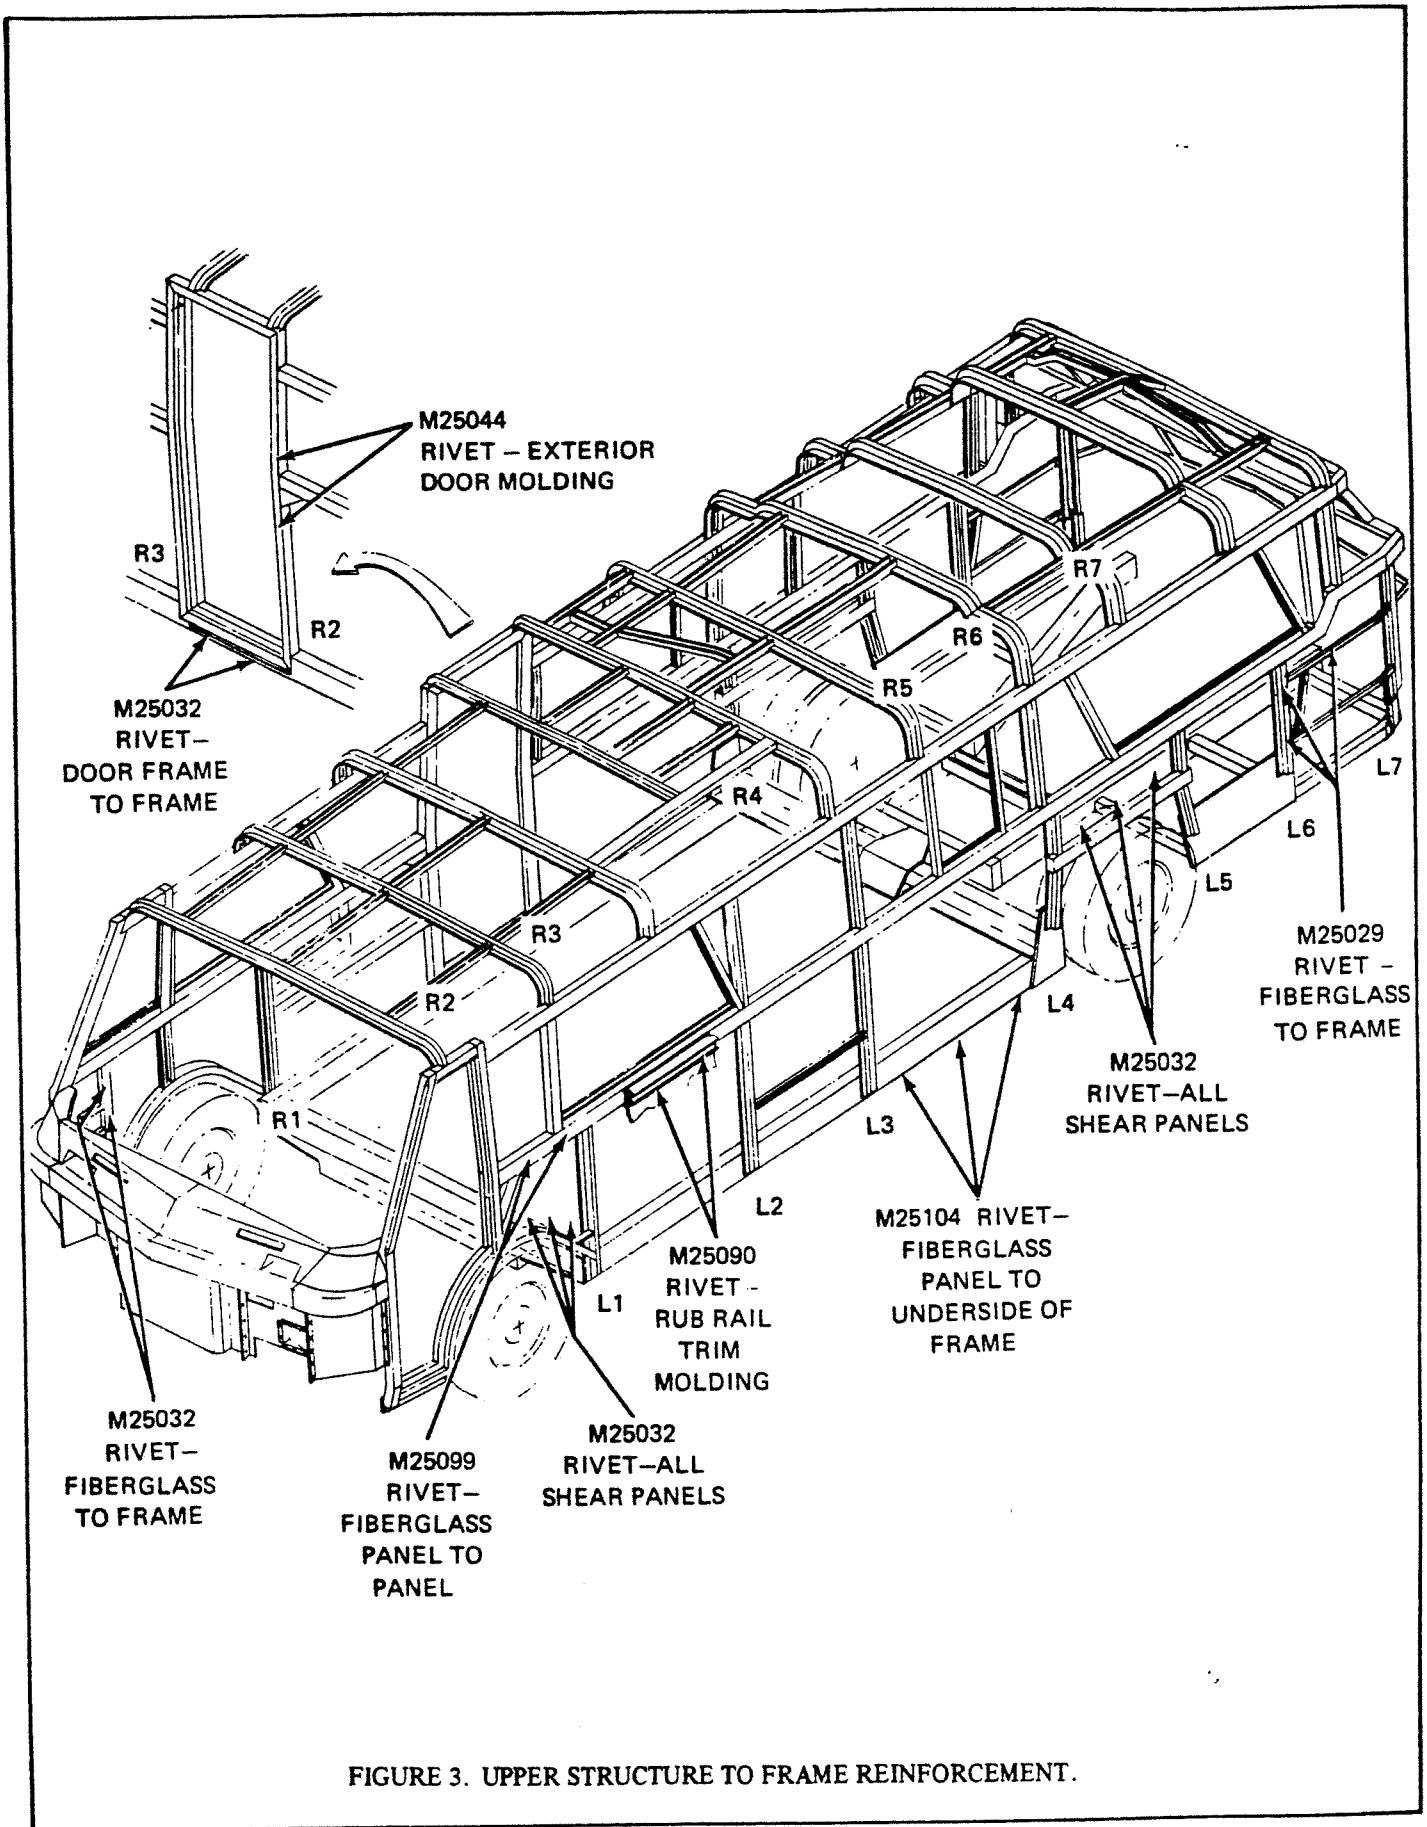
FIGURE 3. UPPER STRUCTURE TO FRAME REINFORCEMENT.

<p>ATTENTION: SERVICE MANAGER</p>	<p>GROUP 2</p>
<p>Condition 1 - Right and left sections forward of rear wheels (positions L4 and R4 in Figure 3) need reinforcement ---4 man hours. Please note that it is not necessary to completely remove coach panels to reinforce for this condition (see Joint Reinforcement Figure 5).</p> <p>Condition 2 - Right and left sections forward of rear wheels (L4 and R4) and all right side sections between rear wheel and front wheel (R3, R2 and R1) plus shear panels in front and rear right side wheel wells (see Figure 3) need reinforcement---8 man hours.</p> <p>Condition 3 - Right and left sections forward of rear wheels (L4 and R4), all right side sections between rear wheel and front wheel (R3, R2 and R1) plus shear panels in front and rear right side wheel wells and left side sections rear of front wheel (L1, L2 and L3), plus shear panels in front and rear left side wheel wells (see Figure 3) need reinforcement. Call factory service representative 408-289-3665 regarding warranty reimbursement <u>before</u> proceeding with the work.</p> <p>Condition 4 - Right and left sections forward of rear wheels (L4 and R4), all right side sections between rear wheel and front wheel (R3, R2 and R1) plus shear panels in front and rear right side wheel wells and left side sections rear of front wheel (L1, L2 and L3), plus shear panels in front and rear left side wheel wells, and all four corners of passenger door frame (see Figure 3) need reinforcement. Call factory service representative 408-289-3665 regarding warranty reimbursement <u>before</u> proceeding with the work.</p> <p><u>INSPECTION</u></p> <p>A thorough inspection of each coach is essential before proceeding with the work to determine if all parts and equipment are in stock and to determine extent of frame reinforcement required.</p> <ol style="list-style-type: none"> 1. Release lower edge of fiberglass side panels on left and right sides of coach (see Figure 5). 2. Cut away foam insulation just enough to inspect all rivets on body sections and shear panels (Figure 1A). 	<p>SUBJECT Frame Reinforcement Instructions</p> <p>MODEL (S) AFFECTED All Motor Homes 00001 to 01050 Model 2900R</p>

<p><u>ACCOMPLISHMENT INSTRUCTIONS</u></p> <p>A. <u>Hull Section to Frame Angles</u> (Figure 3, positions L4, R4, R2 and R3)</p> <ol style="list-style-type: none"> 1. Make certain coach is level at all four jacking points. Jack up body until distance from horizontal strut (just forward of right rear wheel) to bottom of frame is 39 1/4" as shown in Figure 4. 2. Realign rivet holes as close as possible. 3. Close gap between upper body section and lower frame with C clamp. 4. Cut out shear panel only as necessary to install reinforcing angles. 5. Grind or file off existing rivet heads to make angles flush with shear panel. 6. Apply zinc chromate primer to reinforcing angles in all areas that come in contact with aluminum. 7. Place reinforcing angles (5109097-01) against the body section and flush with lower frame. Secure with C clamps. 	<p>MODEL (S) AFFECTED</p> <p>All Motor Homes 00001 to 01050 Model 2900R</p>
