Group 2 Body Structure

Service Bulletin

NUMBER 2902-30001

FIGURE 1. TYPICAL SECTION AND FRAME CONDITIONS.

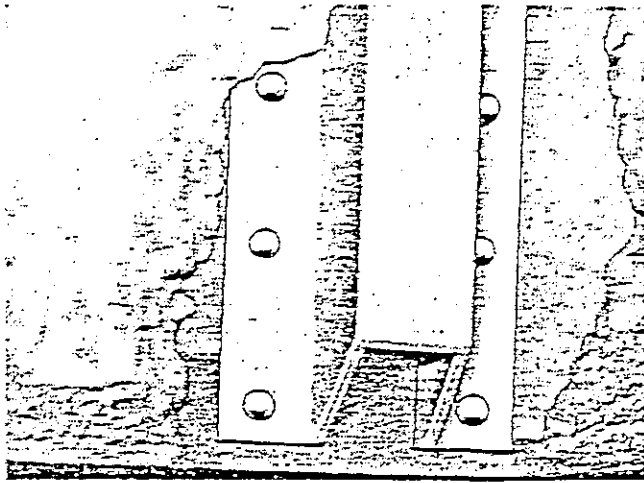
(A) Good section at frame proper cut-away of foam for rivet inspection

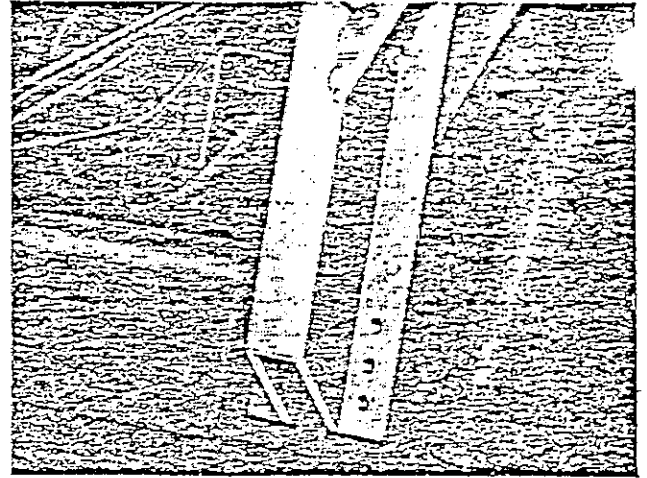
(B) Right front section with missing rivets

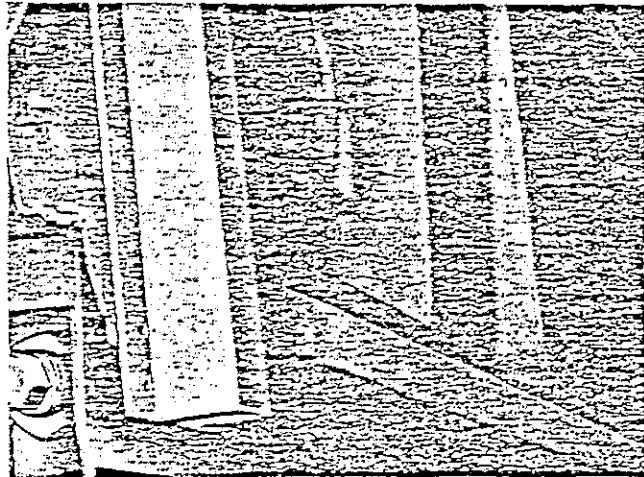
(C) Right rear support section pulled away from lower frame

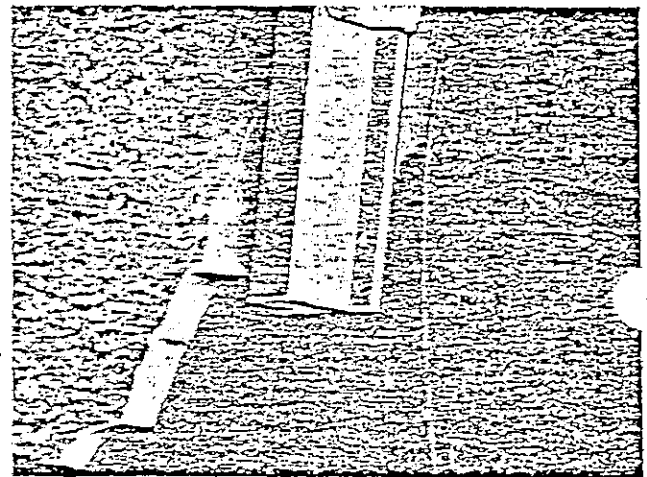
(D) Left rear support section pulled away from lower frame

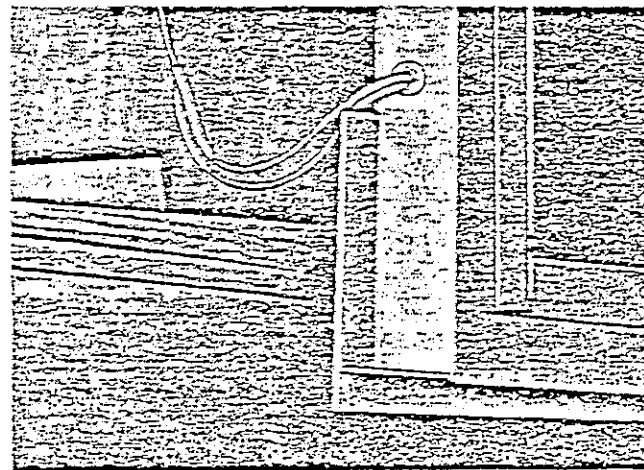
(E) Passenger door frame pulled away from lower frame

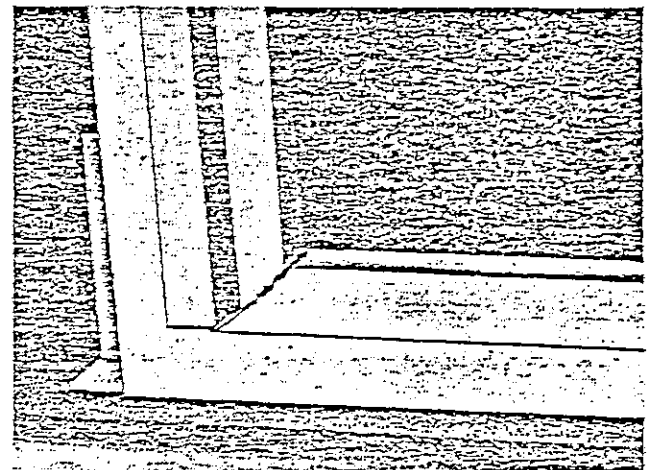
(F) Hairline crack lower aft corner of passenger frame

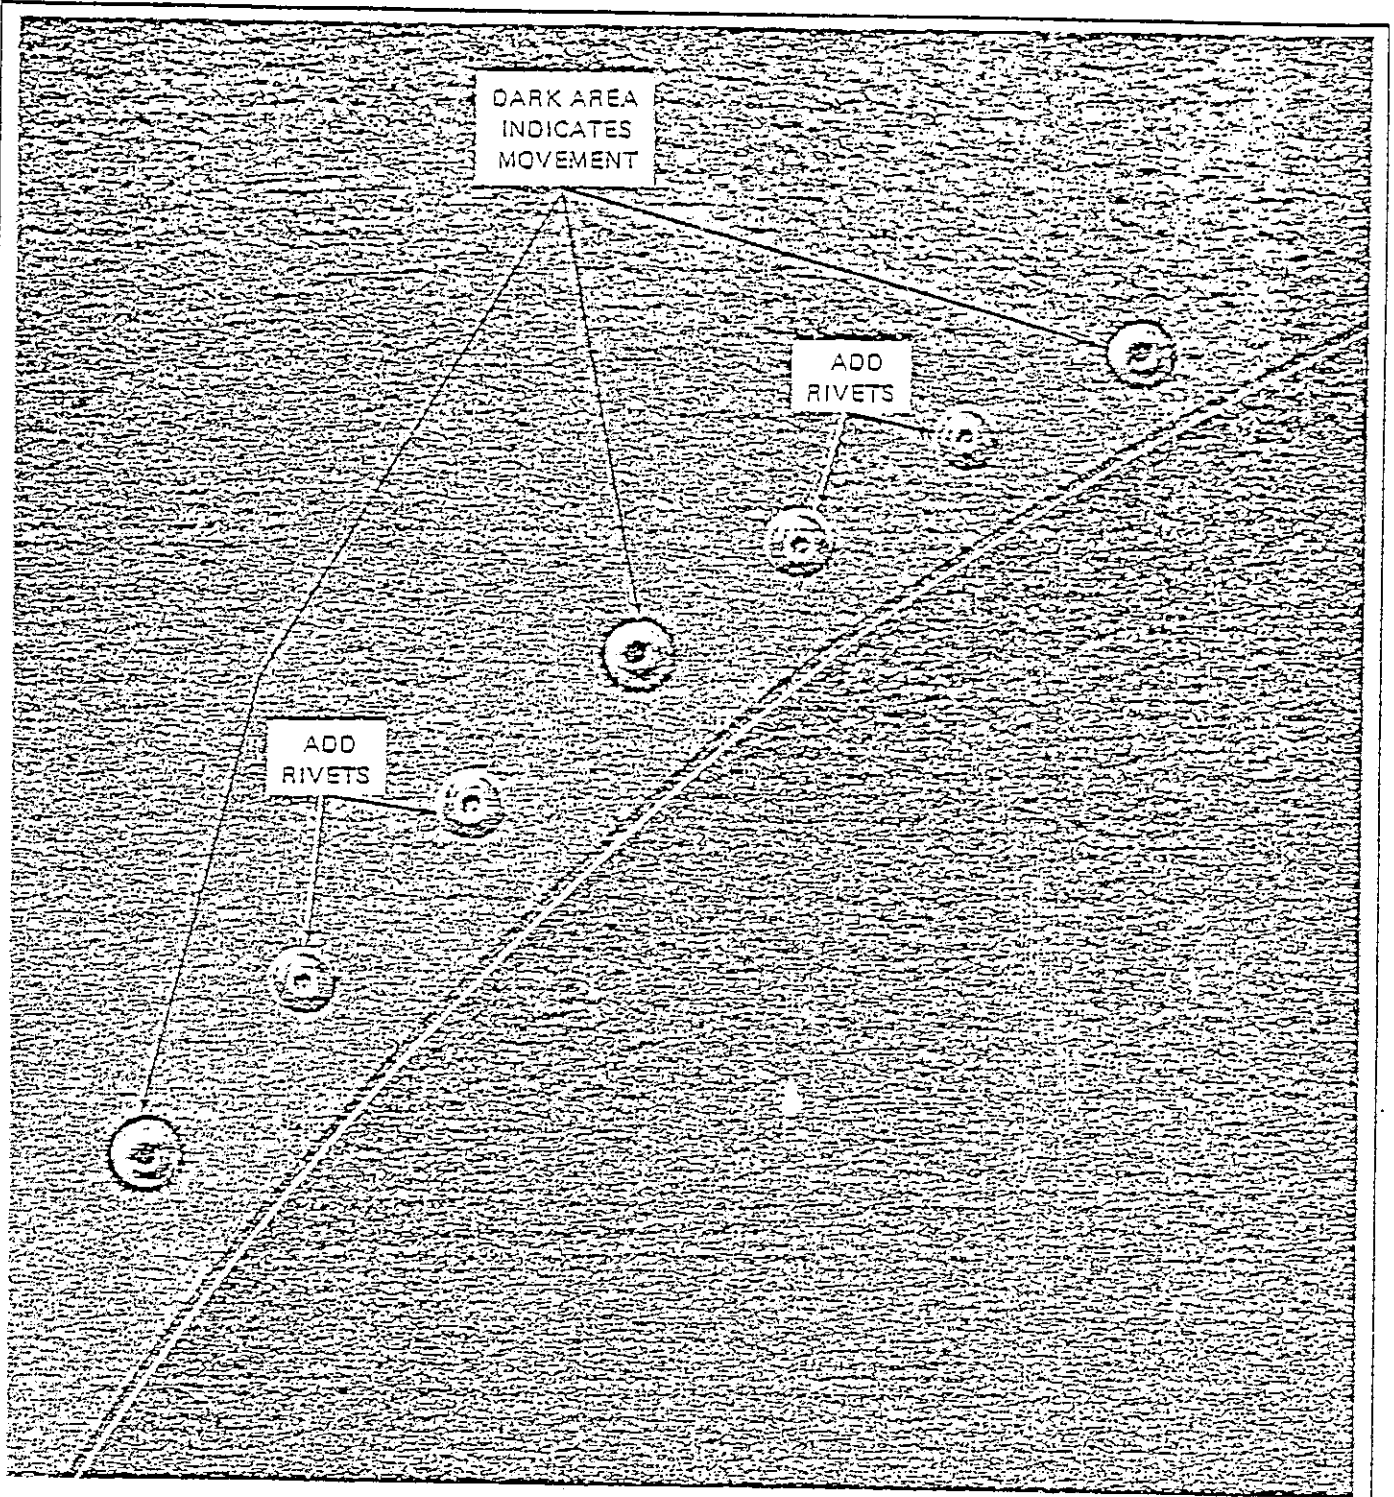
FIGURE 2. SHEAR PANEL TO WHEEL WELL CONNECTION.

<p>ATTENTION: SERVICE MANAGER</p>	<p>GROUP 2</p>
<p>3. Inspect all body section to frame mounts and door for missing rivets, possible movement or disfiguration of rivets (Figure 2) or movement of body section or door frame away from lower frame (Figures 1 and 3).</p> <p>4. Inspect shear panels for missing rivets, possible movement or disfiguration of rivets (Figure 2) or movement of shear panel away from upper body sections. Note: If rivets show signs of movement, add two new rivets between each pair of existing rivets as shown in Figure 2.</p> <p>5. If all upper body section to lower frame rivets are in place and show no signs of deterioration, no reinforcement is necessary <u>except</u> at the right and left body sections (L4 and R4, Figure 3) forward of the rear wheels. New frame reinforcing angles will be added at these points regardless of the condition of the existing section and rivets.</p>	<p>SUBJECT Frame Reinforcement Instructions</p>

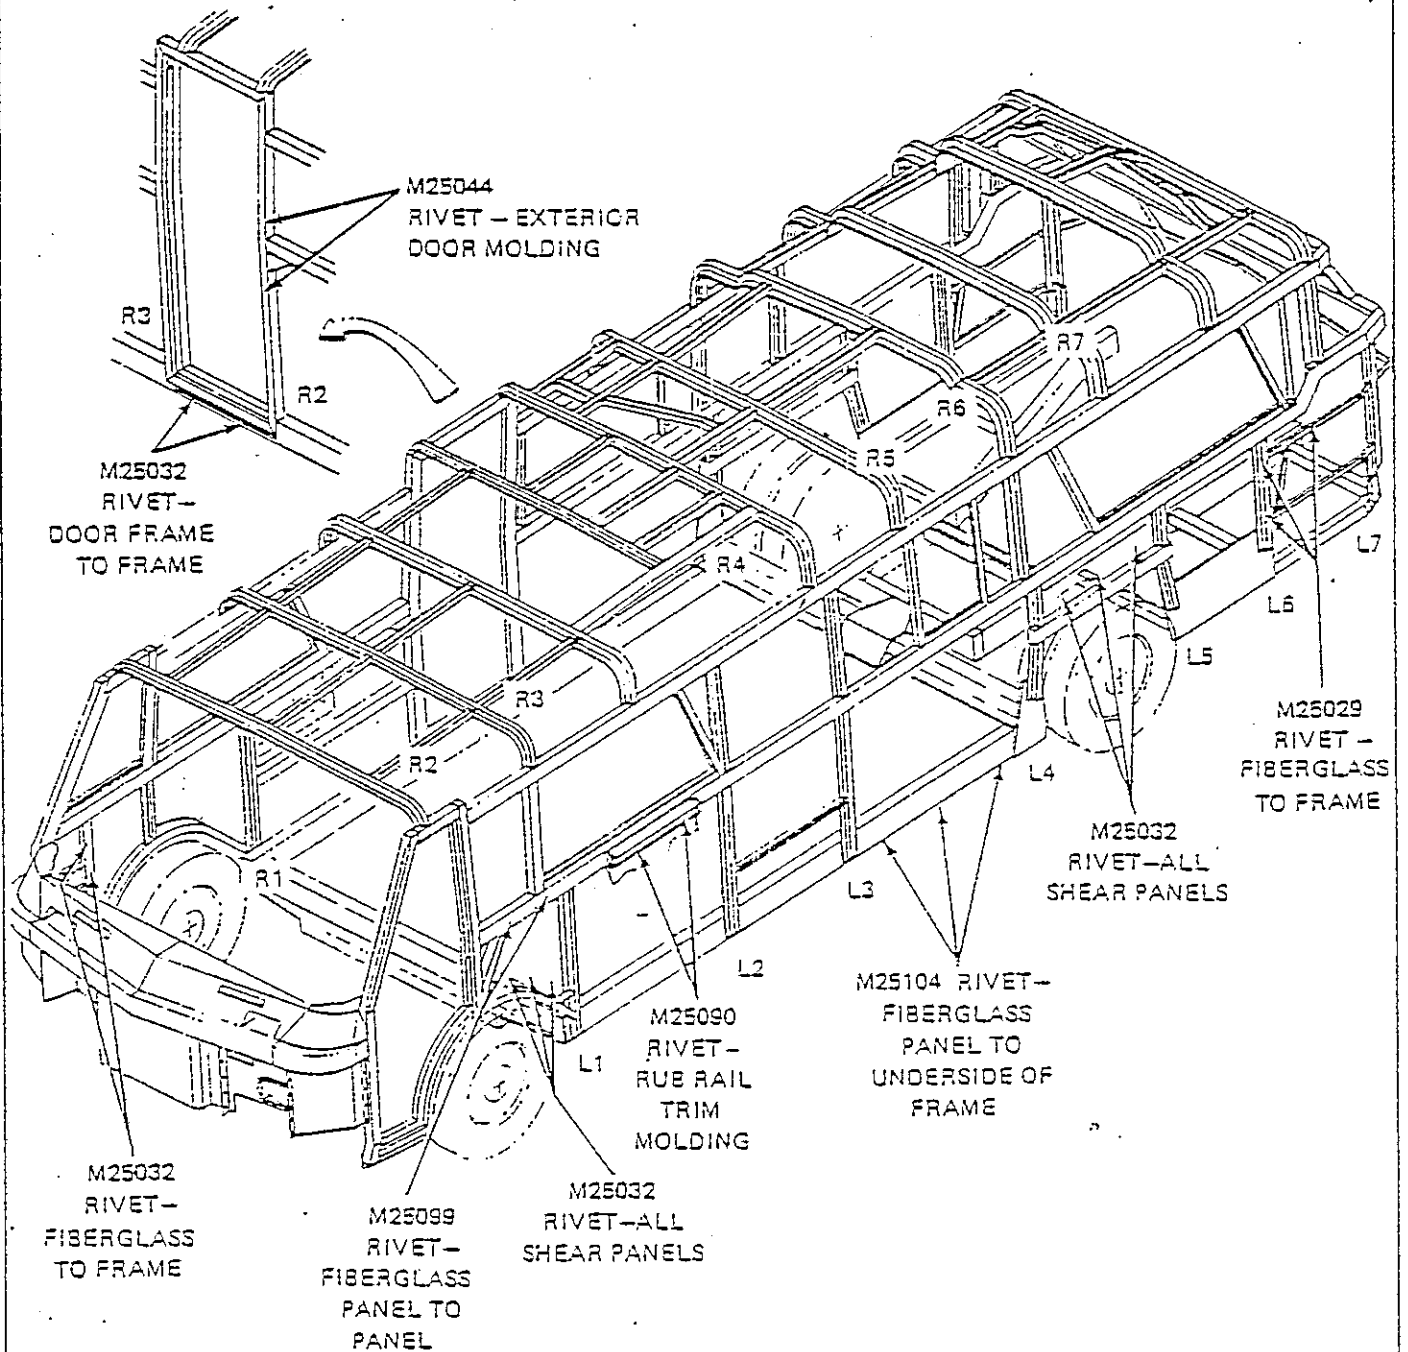
FIGURE 3. UPPER STRUCTURE TO FRAME REINFORCEMENT.

<p>ATTENTION: SERVICE MANAGER</p>	<p>GROUP 2</p>
<p>Condition 1 - Right and left sections forward of rear wheels (positions L4 and R4 in Figure 3) need reinforcement ---4 man hours. Please note that it is not necessary to completely remove coach panels to reinforce for this condition (see Joint Reinforcement Figure 5).</p>	<p>SUBJECT Frame Reinforcement Instructions</p>
<p>Condition 2 - Right and left sections forward of rear wheels (L4 and R4) and all right side sections between rear wheel and front wheel (R3, R2 and R1) plus shear panels in front and rear right side wheel wells (see Figure 3) need reinforcement---8 man hours.</p>	<p>MODEL (S) AFFECTED All Motor Homes 00001 to 01050 Model 2900R</p>
<p>Condition 3 - Right and left sections forward of rear wheels (L4 and R4), all right side sections between rear wheel and front wheel (R3, R2 and R1) plus shear panels in front and rear right side wheel wells and left side sections rear of front wheel (L1, L2 and L3), plus shear panels in front and rear left side wheel wells (see Figure 3) need reinforcement. Call factory service representative 408-289-3665 regarding warranty reimbursement <u>before</u> proceeding with the work.</p>

<p>Condition 4 - Right and left sections forward of rear wheels (L4 and R4), all right side sections between rear wheel and front wheel (R3, R2 and R1) plus shear panels in front and rear right side wheel wells and left side sections rear of front wheel (L1, L2 and L3), plus shear panels in front and rear left side wheel wells, and all four corners of passenger door frame (see Figure 3) need reinforcement. Call factory service representative 408-289-3665 regarding warranty reimbursement <u>before</u> proceeding with the work.</p>	
<p><u>INSPECTION</u></p> <p>A thorough inspection of each coach is essential before proceeding with the work to determine if all parts and equipment are in stock and to determine extent of frame reinforcement required.</p> <ol style="list-style-type: none"> 1. Release lower edge of fiberglass side panels on left and right sides of coach (see Figure 5). 2. Cut away foam insulation just enough to inspect all rivets on body sections and shear panels (Figure 1A).

<p><u>ACCOMPLISHMENT INSTRUCTIONS</u></p> <p>A. <u>Hull Section to Frame Angles</u> (Figure 3, positions L4, R4, R2 and R3)</p> <ol style="list-style-type: none"> 1. Make certain coach is level at all four jacking points. Jack up body until distance from horizontal strut (just forward of right rear wheel) to bottom of frame is 39 to 39 1/4" as shown in Figure 4. 2. Realign rivet holes as close as possible. 3. Close gap between upper body section and lower frame with C clamp. 4. Cut out shear panel only as necessary to install reinforcing angles. 5. Grind or file off existing rivet heads to make angles flush with shear panel. 6. Apply zinc chromate primer to reinforcing angles in all areas that come in contact with aluminum. 7. Place reinforcing angles (5109097-01) against the body section and flush with lower frame. Secure with C clamps. 	<p>MODEL (S) AFFECTED</p> <p>All Motor Homes 00001 to 01050 Model 2900R</p>
