Group 2 Body Structure

Service Bulletin

NUMBER 2902-30001

FIGURE 1. TYPICAL SECTION AND FRAME CONDITIONS.

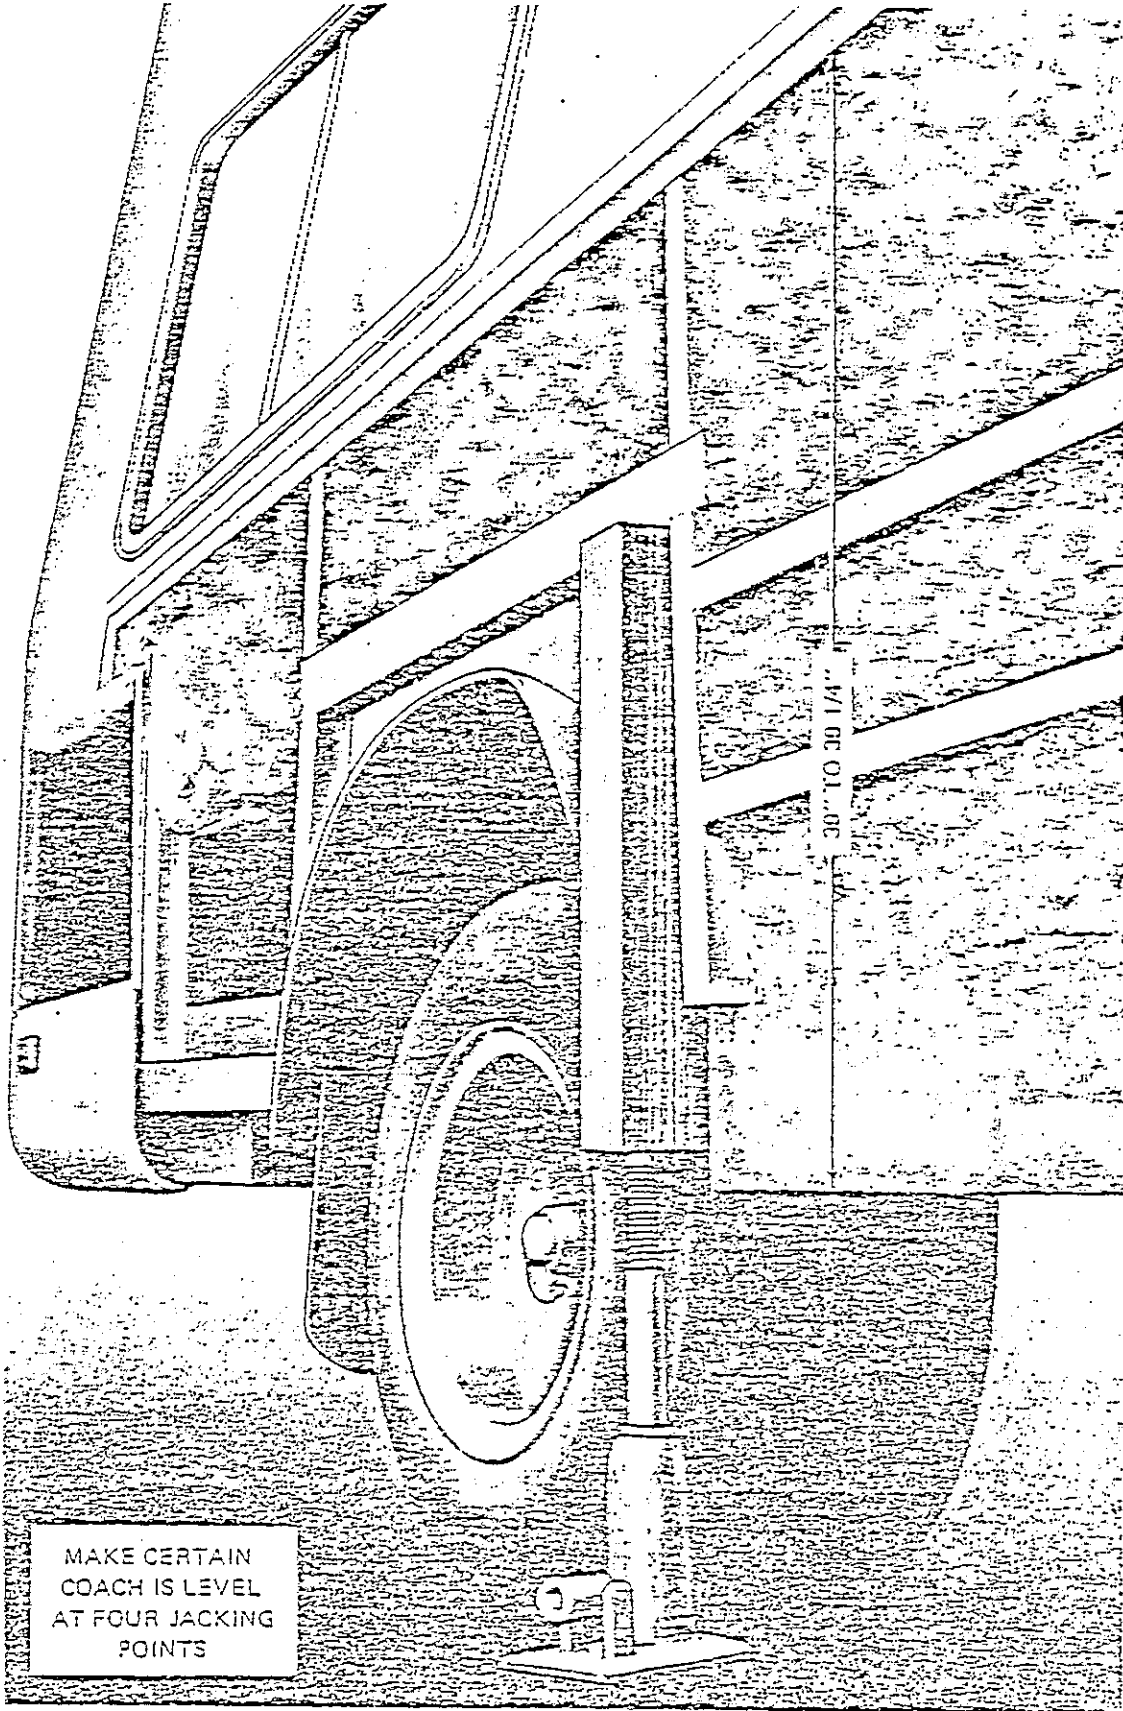
FIGURE 4. BODY TO FRAME DIMENSION.

<p><u>ACCOMPLISHMENT INSTRUCTIONS</u></p> <p>A. <u>Hull Section to Frame Angles</u> (Figure 3, positions L4, R4, R2 and R3)</p> <ol style="list-style-type: none"> 1. Make certain coach is level at all four jacking points. Jack up body until distance from horizontal strut (just forward of right rear wheel) to bottom of frame is 39 to 39 1/4" as shown in Figure 4. 2. Realign rivet holes as close as possible. 3. Close gap between upper body section and lower frame with C clamp. 4. Cut out shear panel only as necessary to install reinforcing angles. 5. Grind or file off existing rivet heads to make angles flush with shear panel. 6. Apply zinc chromate primer to reinforcing angles in all areas that come in contact with aluminum. 7. Place reinforcing angles (5109097-01) against the body section and flush with lower frame. Secure with C clamps. 	<p>MODEL (S) AFFECTED</p> <p>All Motor Homes 00001 to 01050 Model 2900R</p>
